THE BURST OF A WALL IN A HIGHWAY
TUNNEL DURING CONSTRUCTION

P. Lunardi

The Burst of a Wall in a Highway Tunnel During Construction. In this note, one of the many instability phenomena which may occur in an underground work jobsite, is duly considered and described. This event, consequent on the rough and sudden pressure relief of the rock mass corresponding to the excavation section, has occurred during the construction of Gran Sasso Highway Tunnel in the Central Apennines.

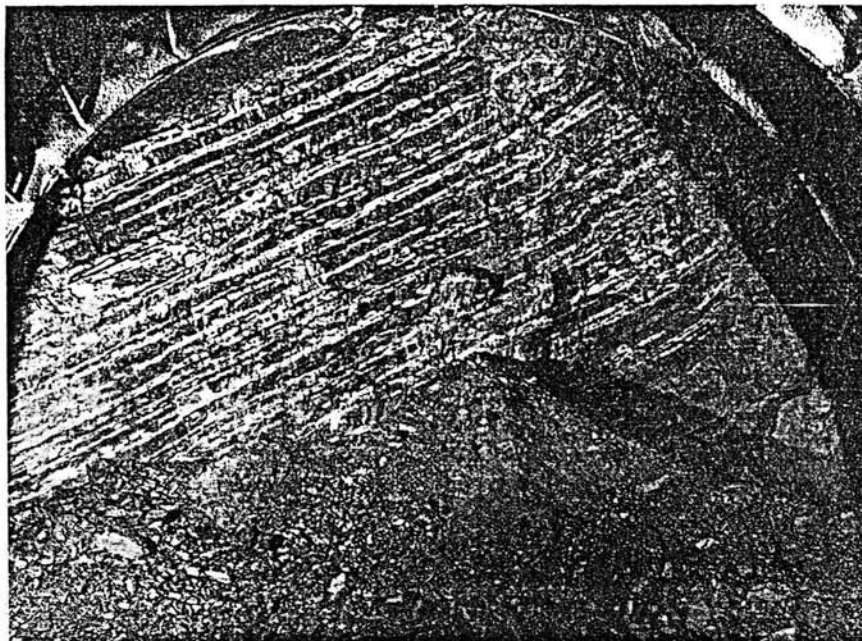
The "Scisti ad Aptici" formation, which the tunnel encountered, on the Assergi side, at chainage 4075 m, in the right hand carriageway and at chainage 4085 m in the left hand carriageway, is separated from the preceding formation by a normal fault, with a few tens of meters throw. The "Scisti ad Aptici" formation is a detrital and biofragmental, fine to medium, seldom coarse and often of rather uniform grain size, limestone. It is thinly layered (10 to 30 cm and exceptionally 1 to 2 m thick layers): 5 to 10 cm thick layers and nodules of weathered, whitish chert are frequently interbedded. Constant strike, nearly parallel to the tunnel axis, and 25° to 30° dip toward the left wall (Fig. 2), occur.

Fig. 2. Heading in the "Scisti ad Aptici" formation
Tunnelbrust im Schiefergestein

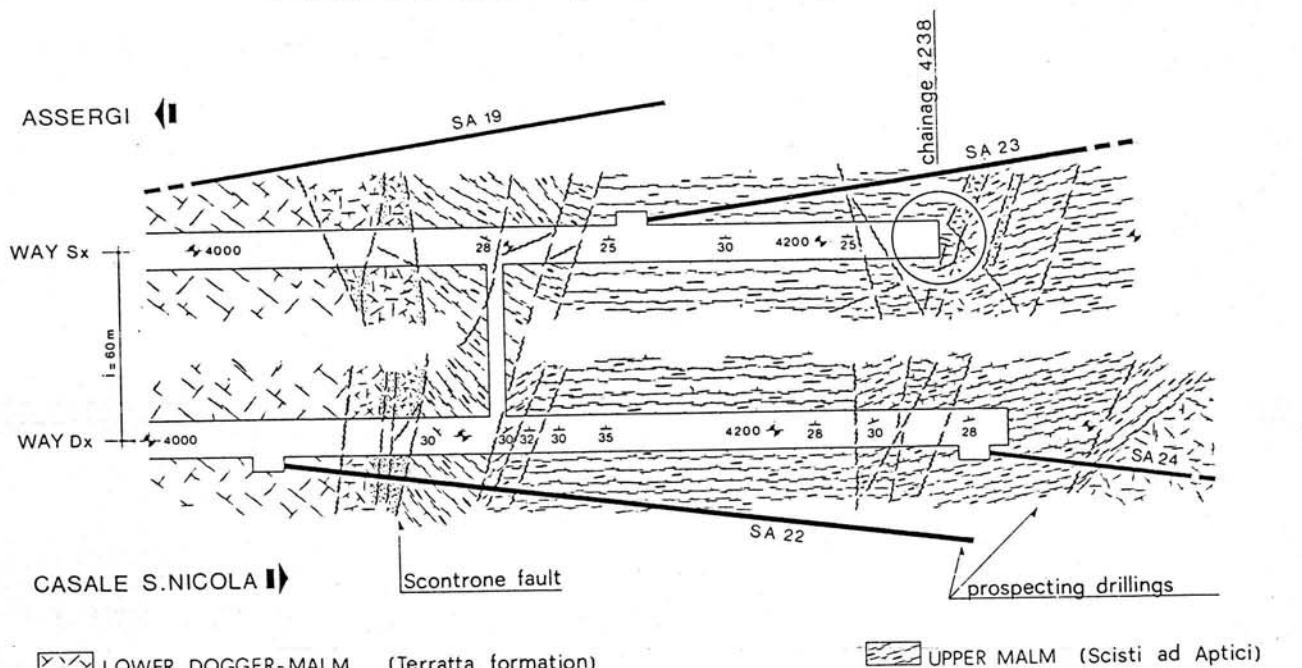
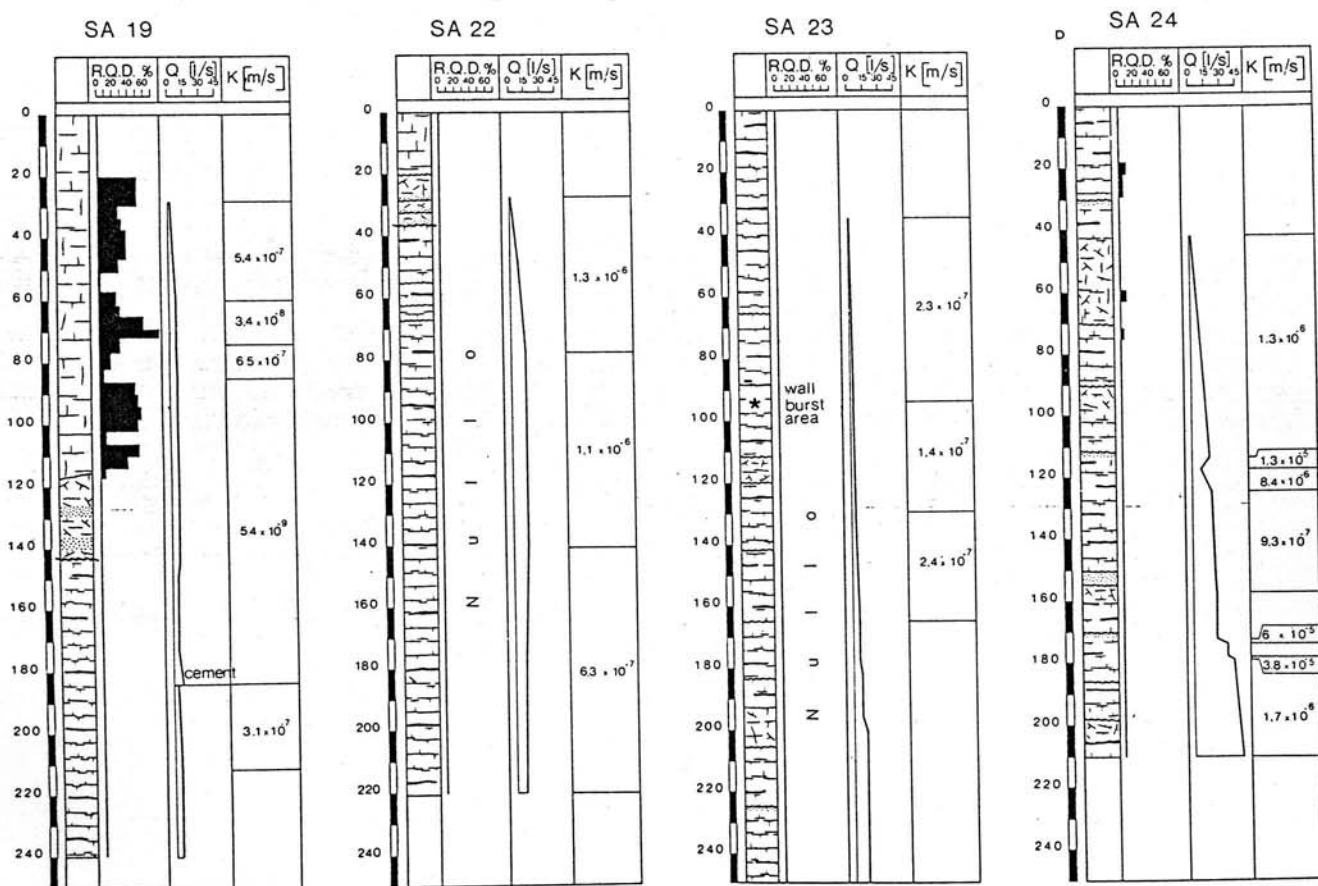
Fig. 3. Bursting of the wall; geological map and logs of the boreholes drilled in the "Scisti ad Aptici" formation

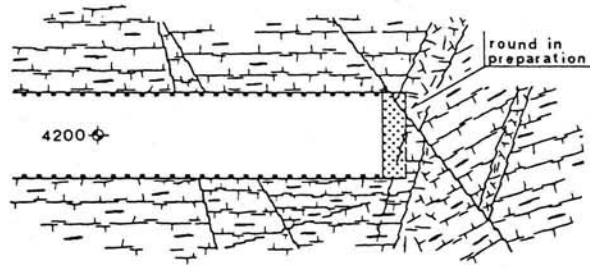
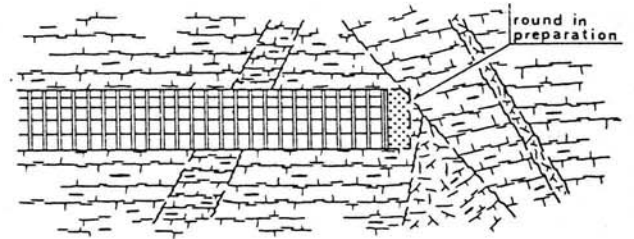
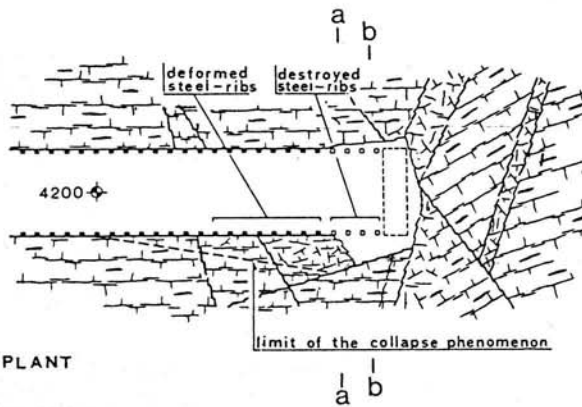
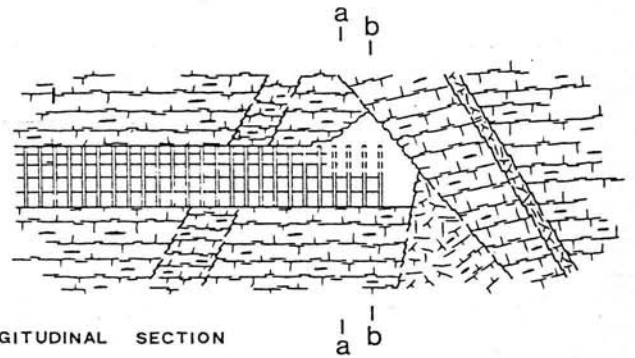
Fig. 4. Burst of the wall; left hand carriageway – “Scisti ad Aptici” formation; geological structural surveys in the burst area

At chainage 4240 m in the left tunnel, under overburden of 1200 m, a singular geostructural feature occurred, represented by a dense interlacement of faults (Fig. 4); after about 15 minutes from shooting rounds, a sudden and violent ejection of a body of rock took place, from the right wall of the tunnel (Fig. 5).

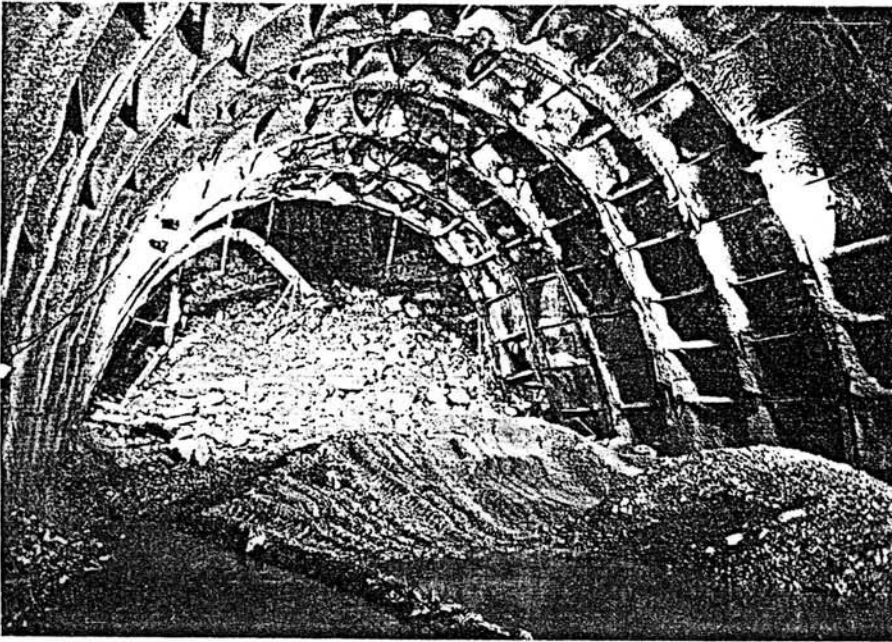
Fig. 5. Condition of the heading after burst; clear diffused laceration in the support
Zustand der Tunnelbrust nach dem Abschlag; es ist eine allgemeine Zerrissenheit des Ausbaues zu bemerken

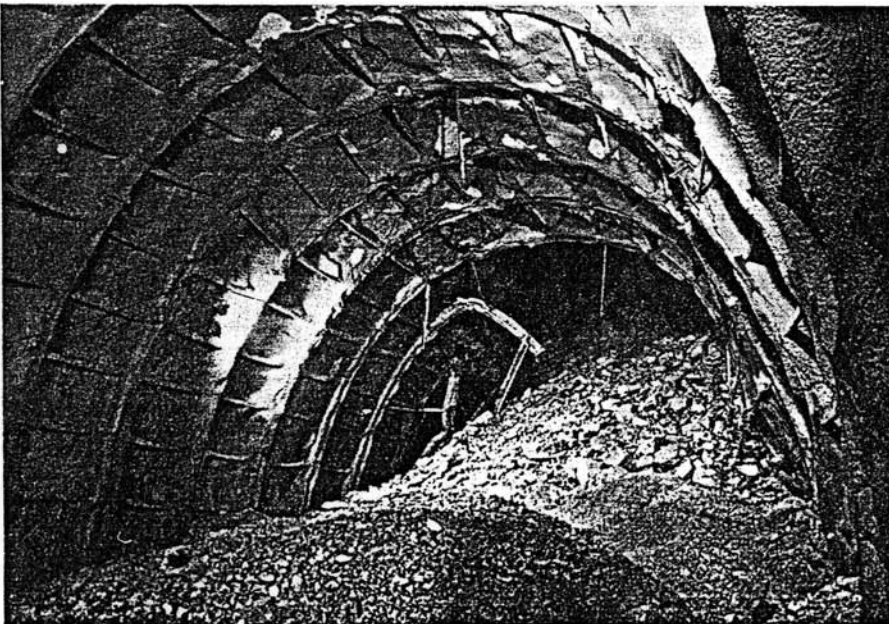
This phenomenon, which had its acme near the heading, in a few meters long stretch, propagated along the right wall, which completely collapsed for a 40 m long stretch, supported by steel ribs and shotcrete (Fig. 6 and 7).

Fig. 6. Condition of the two walls at the burst area: — right wall: collapsed and bulged; — left wall: practically undisturbed
Zustand der Ulmen vor der Brustzone: — rechte Ulme: geknickt und angeschwollen; — linke Ulme: praktisch ungestört

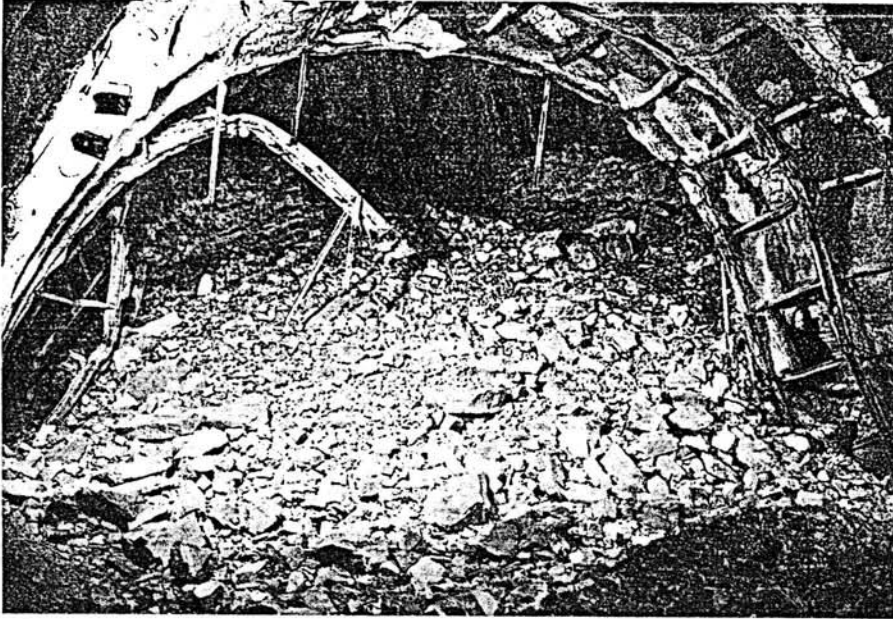
Fig. 7. Heading in the burst area
Tunnelbrust im Vortrieb

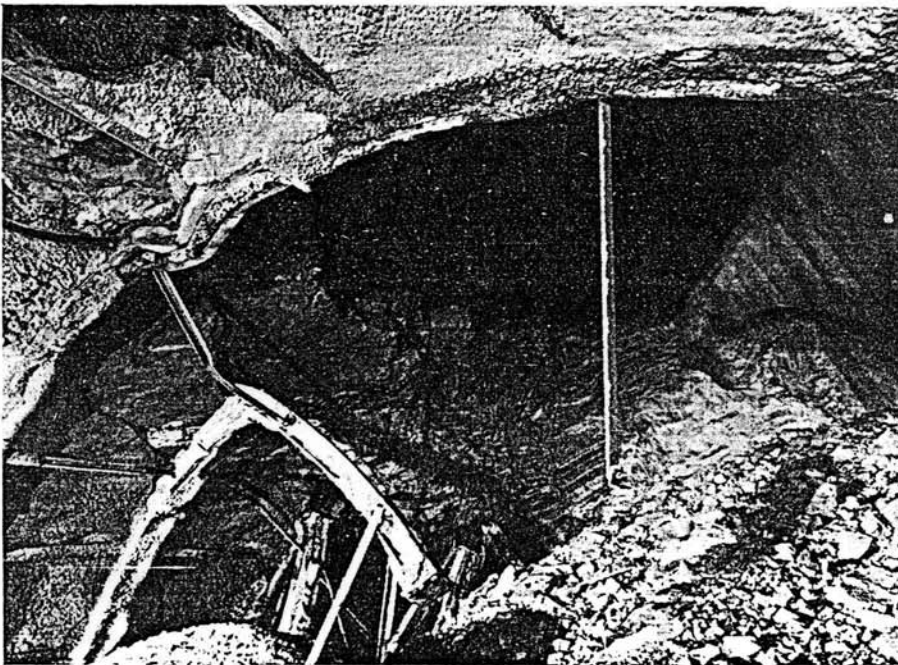
Such an accident caused the complete destruction of the last four ribs (Fig. 8 and 9) and the warping, under axial loads, of other eight ribs (Fig. 10), the extensive tearing of the shotcrete layer and the failure of the rock surface immediately beneath the shotcrete, in the area near the heading.

Fig. 8. Details of destroyed ribs
Ausschnitte des zerstörten Ausbaues

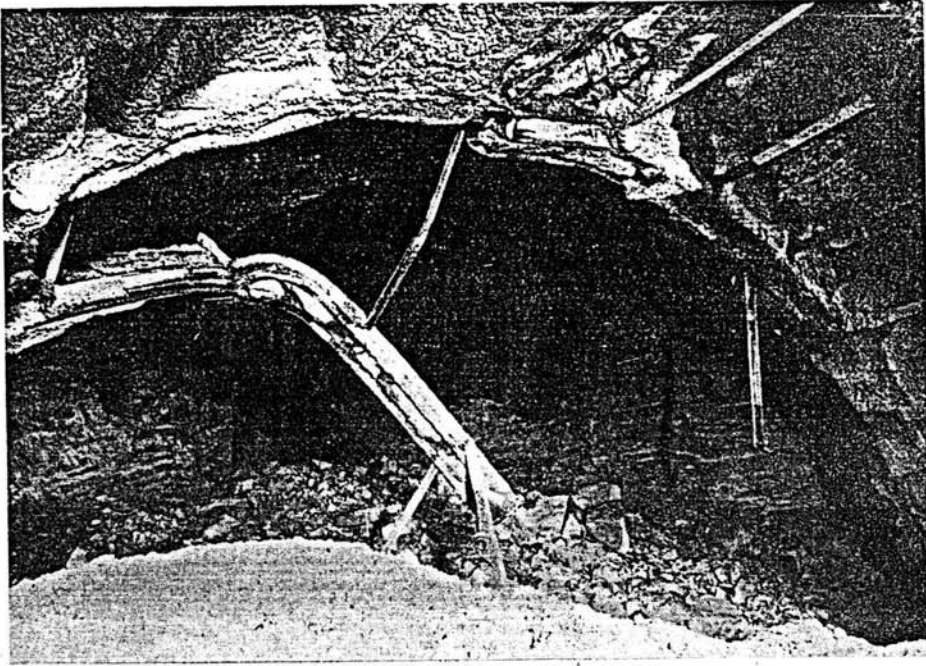
Fig. 9. Details of destroyed ribs; on the background, fault plane with marked oxidation traces
Ausschnitte des zerstörten Ausbaues; im Hintergrund sieht man die Glättung der Störung mit Oxydationsspuren

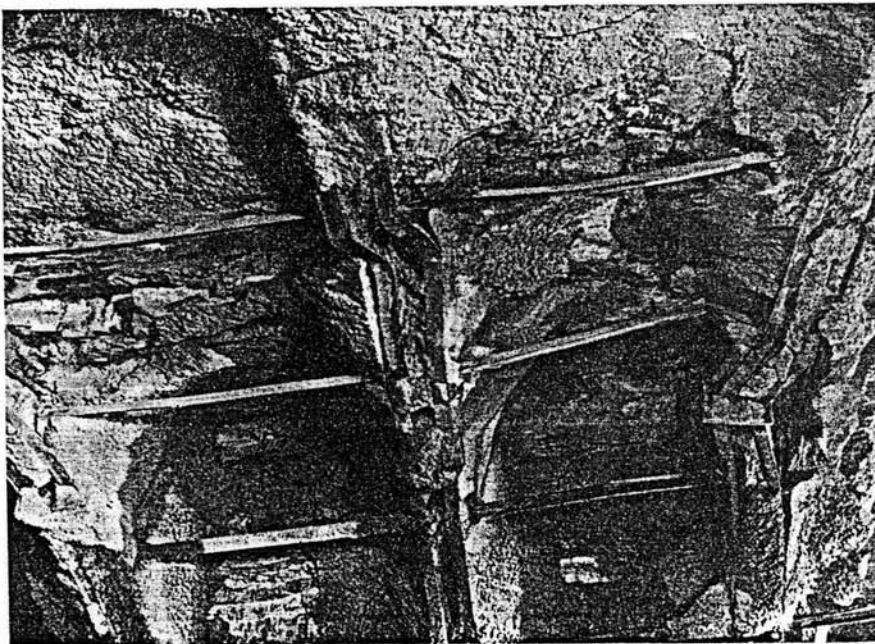
Fig. 10. Detail of warped ribs behind the burst area
Ausschnitte der verformten Stahlbögen vor der Brustzone

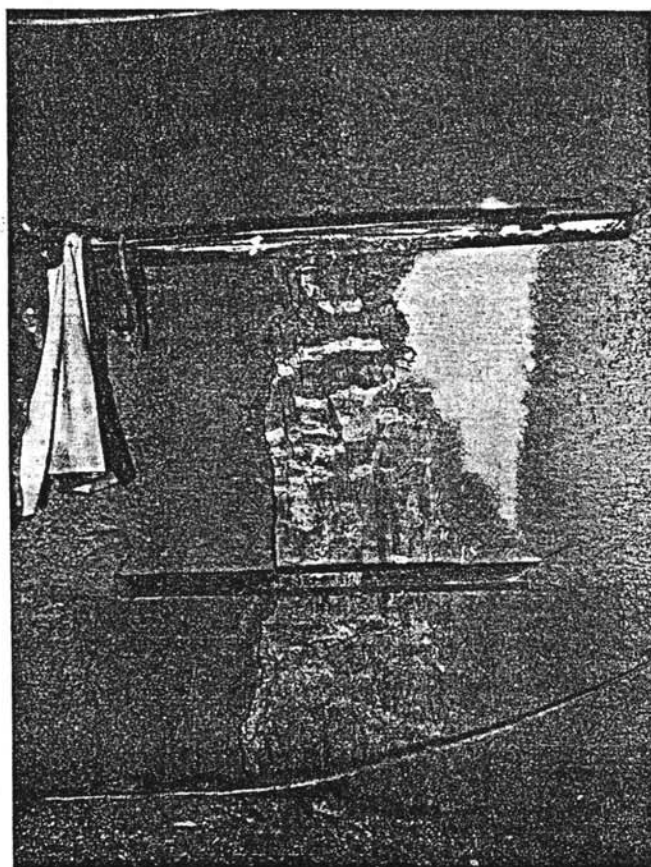
The failure was elastic-fragile as confirmed by the abrupt and violent development of the phenomenon, as well as by the occurrence of frequent subvertical fractures, present in the right wall and totally absent in the left wall (Fig. 14, 15, 16 and 17) of the tunnel.

Fig. 14. Right-hand wall; condition of limestone about 20 m from burst area
Rechte Ulme: Zustand des Kalksteines (etwa 20 m vor der Brust)

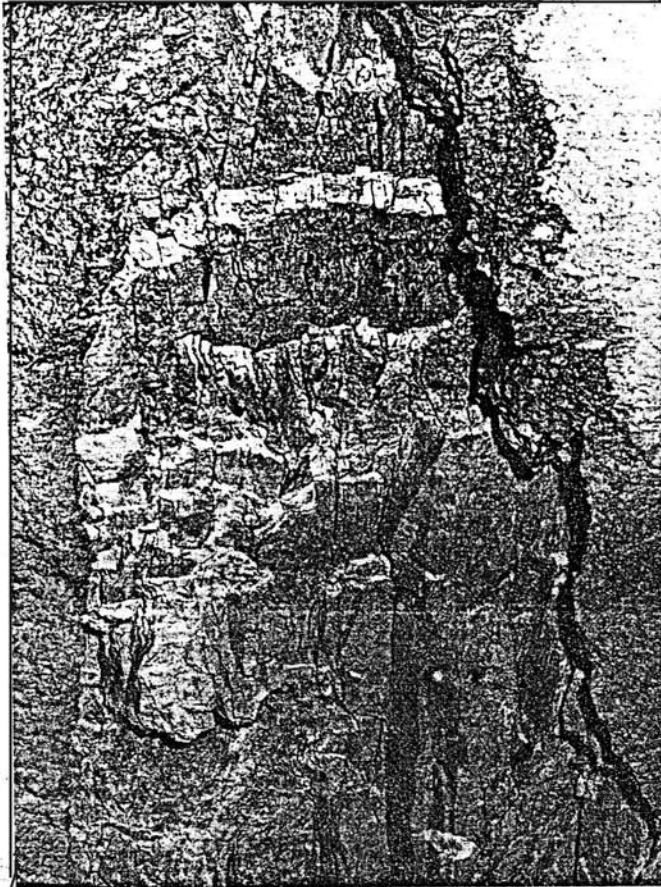
Fig. 15. Right-hand wall; details of collapsed material with marked subvertical pressure-relief fractures

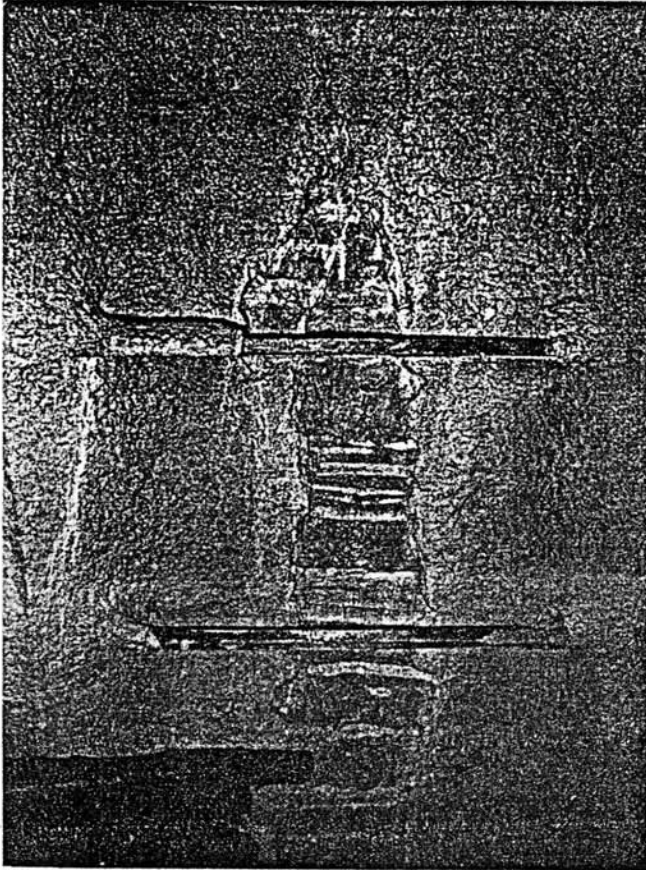
Fig. 16. Left-hand wall; condition of limestone about 20 m from burst area
Linke Ulme: Zustand des Kalksteines (etwa 20 m vor der Brust)

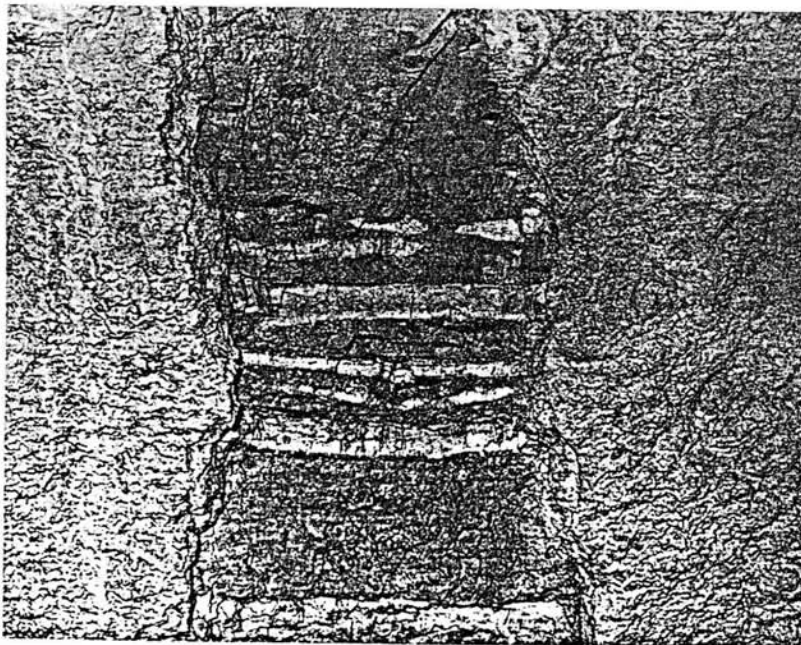
Fig. 17. Left-hand wall; details of limestone with flint layers undisturbed by burst
Linke Ulme: Ausschnitte des ungestörten Kalksteines (mit erkennbaren Feuersteinschichten)

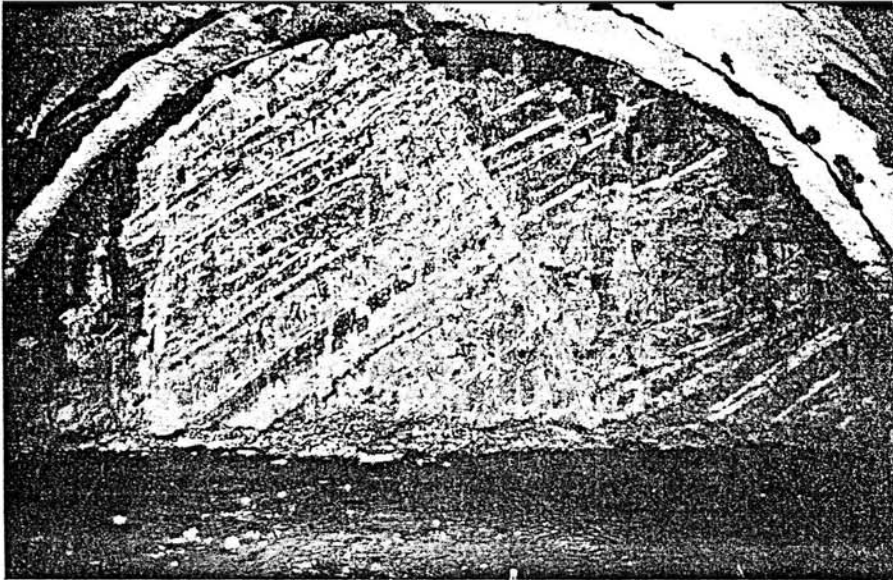
Fig. 18. Heading-bench after chainage 4240; "Scisti ad Aptici" showing a fault subparallel to the tunnel axis
Halbquerschnittvortrieb (bergseitig vorgetriebene Länge 4240 m); der Schiefer zeigt Spuren der Störung, die subparallel zu der Tunnelachse liegt

Safety precautions were taken to continue the excavation in the "Scisti ad Aptici" formation in both tubes, after chainage 4238 m left hand tunnel. The most effective measures, which allowed safely tunnelling, avoiding instability, were either the reduction of the unsupported height of the wall (heading-bench

method: Fig. 18), and the accurate and systematic survey, by experienced personnel, of joints and faults affecting the whole section and their three dimensions recording.
