## **Geological unpredictability in tunnels**

### **Design and construction difficulties during construction of the "Pale" tunnel for the new SS 77 state road of "Val di Chienti"**

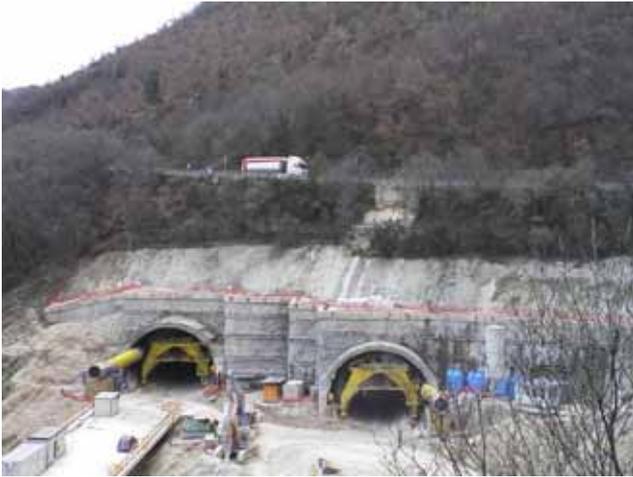
**Pic. 1** The "Pale" tunnel. Portal facing Foligno

Near the portal opening facing Foligno, the tunnel passes under the SS 77 with minimum coverage of about 15 m (Pic. 1).

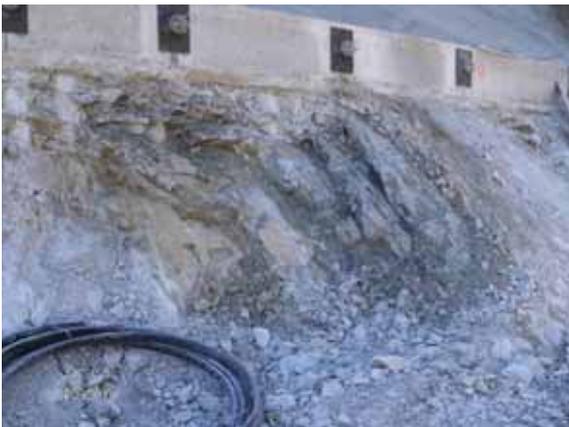
**Pic. 2a** Maiolica in the bulkhead head beam

These predictions were apparently confirmed both by the results of the preparatory earthworks for the portal bulkheads, which had brought to light the lithoid mass (Pic. 2a, 2b, 2c), and by the excavation of the first 15 m of the north bore, which had constantly faced a lithoid mass belonging to the Maiolica formation, possessing good geomechanical characteristics (Pic. 3).

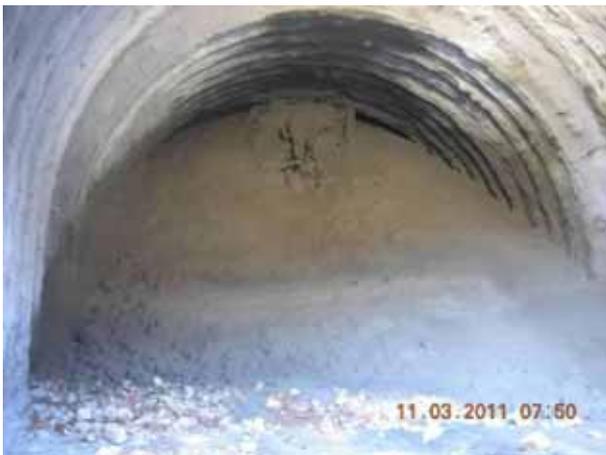
**Pic. 4** Material flowed into the tunnel

Everything was proceeding according to the design expectations when, suddenly, during the excavation of the northern tube, on the 11/03/2011, and having just placed the steel rib at around pk (chainage) 4+935 – therefore after 16.70 m from the portal and only 2 m after the survey pk 4+933, which had highlighted an entirely rock face (Pic. 3), arid material started to collapse from the top of the crown. Shotcrete was promptly pumped to contain the situation. However, the instability was rapidly and unexpectedly evolving. A patchwork of totally loose light-brown material, from fine sand to coarse gravel with cobbles, started to flow constantly and rapidly through a fissure of little more than 1 m in width that had opened on the cavity at the crown key, causing a sort of hourglass effect. The violence of the effect, which had developed in the absence of water, made it necessary to rapidly retreat all machines and operators, while the imbalance continued for minutes and only stopped once the accumulated material had completely covered the face and closed the crown (Pic. 4).

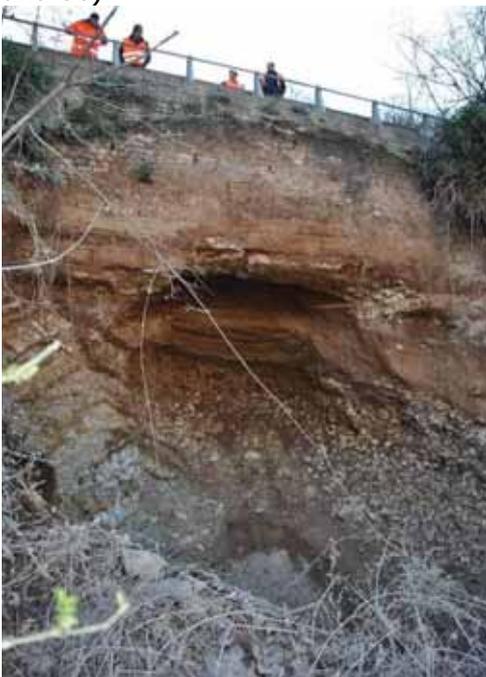
**Pic. 5a** Overground gap, downstream the SS 77 (detail)

Due to the modest overburden (about 15 m), the crumbling of material into the tunnel left on the ground, vertically to the face, a wide gap intercepting the slope downstream the SS 77 (Pic. 5a and 5b).

The necessary precautions were immediately taken, such as re-directing the traffic of the SS 77 onto a single alternating one-way carriageway (the upstream one) and by protecting the safety of the face with great amounts of cement and shotcrete.

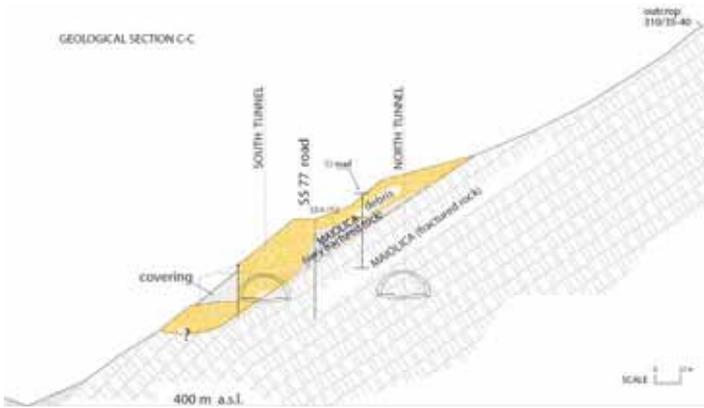
The stability analyses of the slope were carried out by referring to the geological section along the greatest dip (Fig. 9a), using the "*shear strength reduction (SSR)*" technique (Fig. 9b, 9c).

**Fig. 9a** Geological section along the greatest dip.

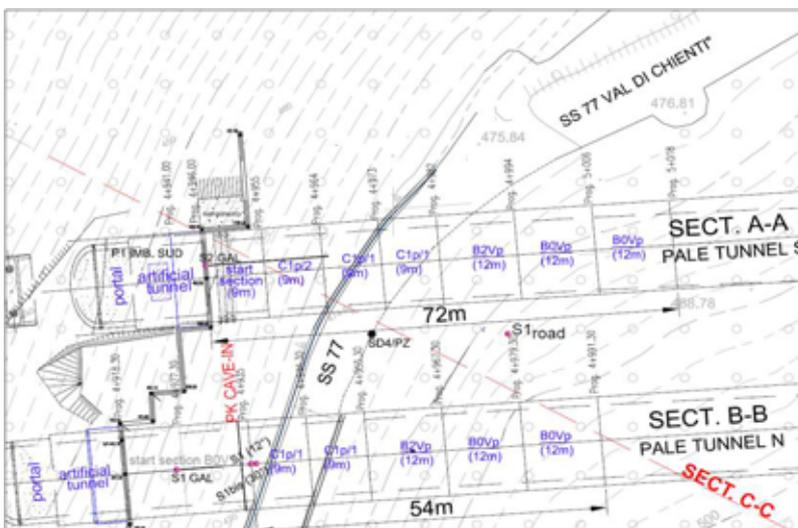
The adopted distribution of the section types is reported in the planimetry of Fig. 14 and in the longitudinal sections of Fig. 15.

Fig. 14 Planimetry, including description of operations.

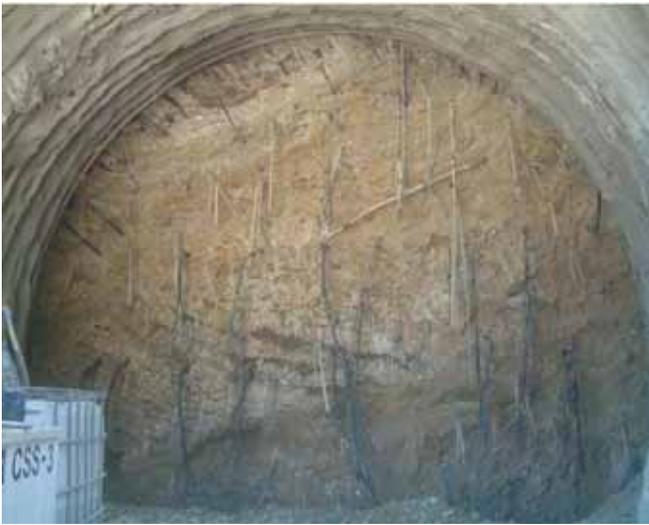
Excavation started from the South tube (Pic. 6) which advanced for about 3 excavation diameters (about 40 m); successively, after having improved the ground mass affected by the cave-in (Fig. 14), advance proceeded from the face of the North tube. The interferences between the two tunnel tubes were thus contained.

**Fig. 6** Debris material at the face of South tube
