THE BURST OF A WALL IN A HIGHWAY
TUNNEL DURING CONSTRUCTION

P. Lunardi

The Burst of a Wall in a Highway Tunnel During Construction. In this note, one of the many instability phenomena which may occur in an underground work jobsite, is duly considered and described. This event, consequent on the rough and sudden pressure relief of the rock mass corresponding to the excavation section, has occurred during the construction of Gran Sasso Highway Tunnel in the Central Apennines.

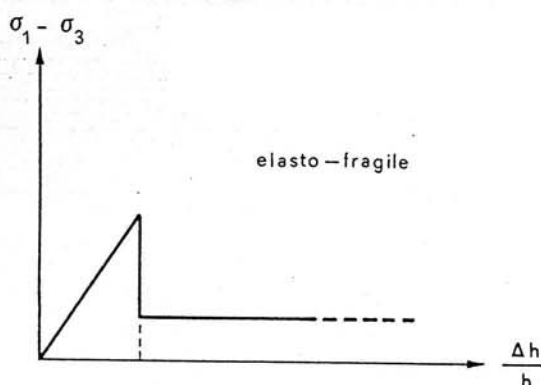
Fig. 11. Diagram 1
Diagramm 1

If it is very rigid (sound and massive rock with good mechanic properties) the rock mass, loaded up to its ultimate strength σ_{gd} , fails in a brittle way ("decoesione") suddenly and abruptly returning, with a violence proportional to the load gradient, the energy stored while overstressed. Such "decoesione" failures occur at well defined points, rather than along the entire excavation line, inducing slight deformation, unless large volumes of rock are involved, whose residual strength decreases till a merely frictional strength (elastic-fragile behaviour: Fig. 11).

Based on these observations and on the dynamic development of the phenomenon, it seems reasonable to classify the described failure as elastic-fragile. Moreover, if λ ratios are assumed, of the order of one, considering the high overburdens present, the Kastner-Fenner theory can be used (Fig. 13c), for the interpretation of the phenomenon.

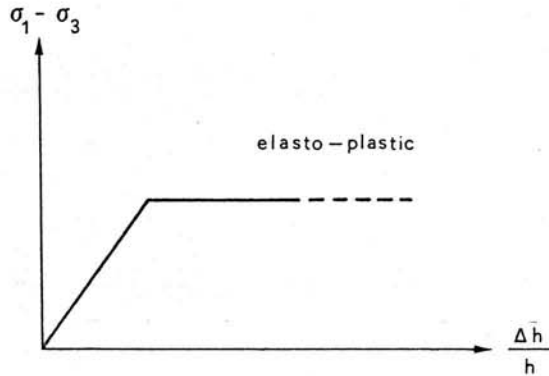
Fig. 12. Diagram 2
Diagramm 2

If low-rigidity rock occur (rock undergone to tectonic actions or of poor mechanical properties) the rock mass, stressed to its ultimate strength σ_{gd} , undergoes ductile failure, returning, with slow and smooth deformations, the energy

stored while overstressed; these deformations take place along the entire excavation line, more or less homogeneously according to the anisotropy of the rock mass. The resulting deformations can be large; if adequately controlled by erecting appropriate support (bolting, shotcreting), they are such as to allow the rock mass to maintain rather good residual strength, exerting in its turn an increasing and progressive supporting action (in connection with the temporary lining) which ensures the excavation stability (elastic-plastic behaviour: Fig. 12).
